# BOLTED FIELD REPAIR OF COMPOSITE STRUCTURES

J. C. Watson, et al.  
McDonnell Douglas Corporation  
McDonnell Aircraft Company  
P.O. Box 516  
St. Louis, Missouri 63166

Final Report

Repairs were demonstrated on both laminate thicknesses. The 3/16 inch laminate was typical of an AV-8B wing skin. The 1/2 inch laminate was typical of an F-18 wing skin. Three sizes of damage holes were investigated for each laminate thickness: 1.0 in., 2.5 in., and 4.0 in. diameters. Two repair concepts were evaluated for each damage configuration.

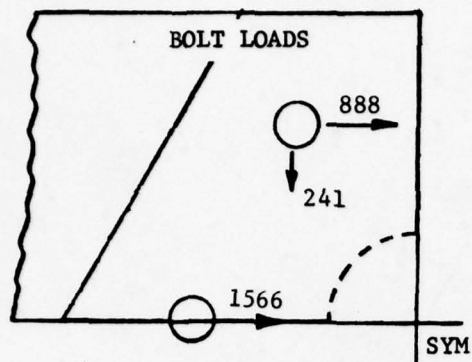
Bolt Dia. = 1/4 in.

0.14 in. Titanium Patch

MAXIMUM BOLT BEARING STRESS IN Gr/Ep 33,460 psi

FIGURE 2-3 NASTRAN SUMMARY - 3/16 LAMINATE 1.0 DIA HOLE REPAIR #1

Figures 2-3 thru 2-14 summarize the NASTRAN predictions for the internal loads and strains for the repair concepts selected for the various hole diameter and panel thickness combinations. Appendix A contains the engineering drawings which describe the patches in detail.

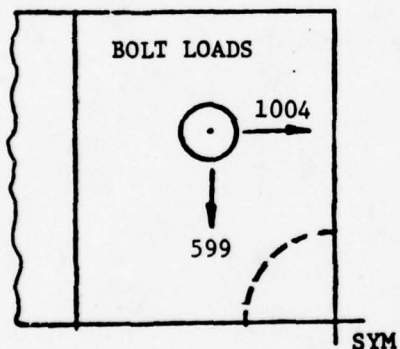
Bolt Dia. = 5/16 in.

0.16 in. Titanium Patch

MAX. BOLT BEARING STRESS IN Gr/Ep 20,000 psi

FIGURE 2-4 NASTRAN SUMMARY-3/16 LAMINATE 1.0 DIA HOLE REPAIR #2

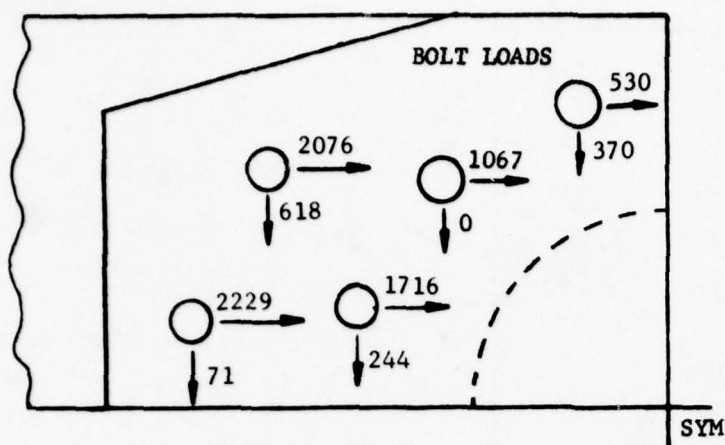
Bolt Dia. = 1/4 in.  
 0.14 in. Titanium Patch  
 $N_X = 6,777$  lb/in.  
 Basic Strain = 4000  $\mu$ in./in.

MAX. BOLT BEARING STRESS IN Gr/Ep 47,650 psi

FIGURE 2-5 NASTRAN SUMMARY-3/16 LAMINATE 2.5 DIA HOLE REPAIR #1

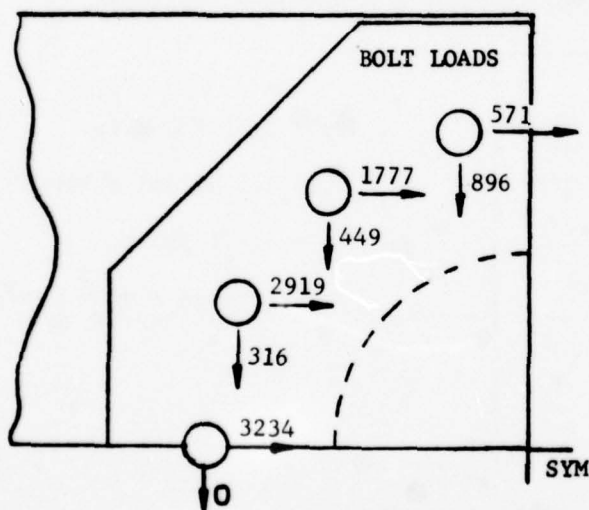
Bolt Dia. = 1/4 in.  
 0.14 in. Titanium Patch  
 $N_X = 6,777$  lb/in.  
 Basic Strain = 4000  $\mu$ in./in.

MAX. BOLT BEARING STRESS IN Gr/Ep 69,100 psi

FIGURE 2-6 NASTRAN SUMMARY-3/16 LAMINATE 2.5 DIA HOLE REPAIR #2

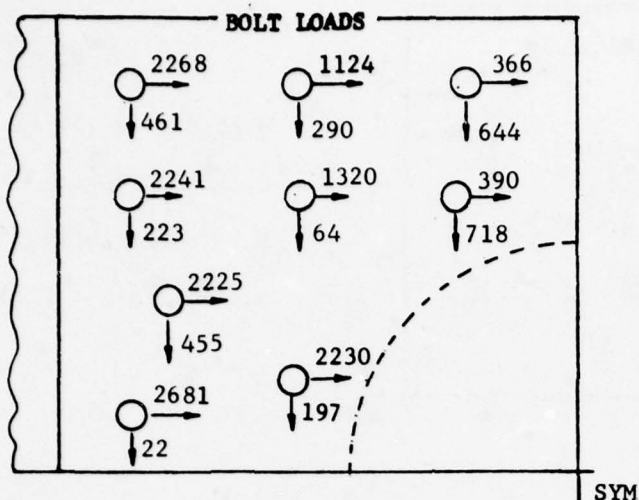
Bolt Dia. = 1/4 in.

0.14 in. Titanium Patch

MAXIMUM BOLT BEARING STRESS IN Gr/Ep 57,286 psi  $\therefore$  AT 57,286 fbru AV-8B CRITERIA IS MET.

FIGURE 2-7 NASTRAN SUMMARY-3/16 LAMINATE 4.0 DIA HOLE REPAIR #1

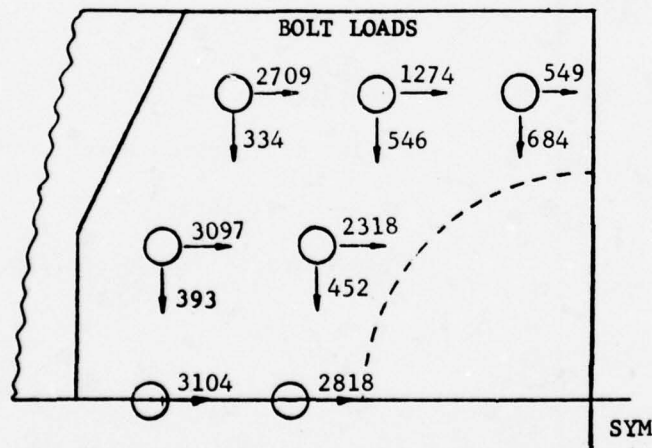
Bolt Dia. = 5/16 in.

0.16 in. Titanium Patch

MAX. BOLT BEARING STRESS IN Gr/Ep 53,350 psi

FIGURE 2-8 NASTRAN SUMMARY-3/16 LAMINATE 4.0 DIA HOLE REPAIR #2

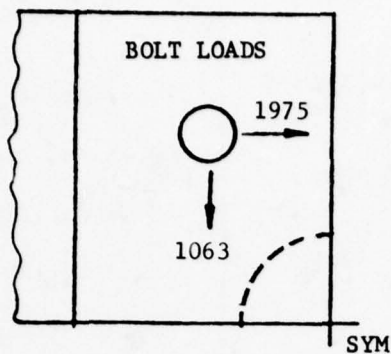
Bolt Dia. = 5/16 in.

0.16 in. Titanium Patch

MAX. BOLT BEARING STRESS IN Gr/Ep 14,350 psi

FIGURE 2-9 NASTRAN SUMMARY-1/2 LAMINATE 1.0 DIA HOLE REPAIR #1

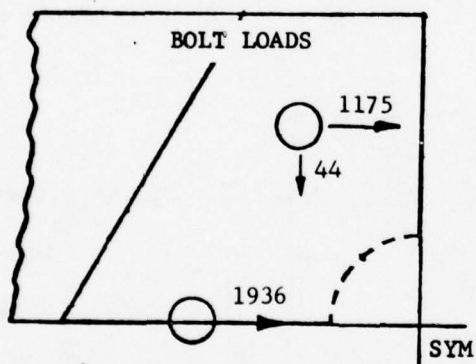
Bolt Dia. = 1/4 in.

0.14 in. Titanium Patch

MAX. BOLT BEARING STRESS IN Gr/Ep 15,488 psi

FIGURE 2-10 NASTRAN SUMMARY-1/2 LAMINATE 1.0 DIA HOLE REPAIR #2

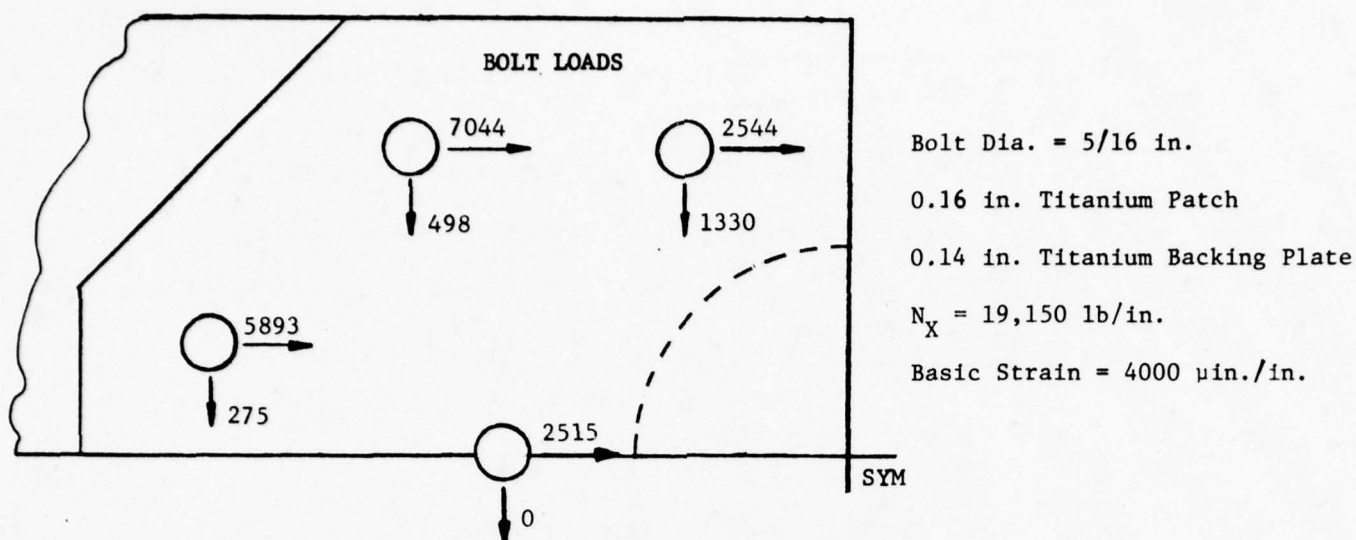
AT EDGE OF HOLE 6927  $\mu$ in./in.  
 AT ANY FASTENER 5042  $\mu$ in./in.  
 AT HIGHEST LOADED FASTENER 4936  $\mu$ in./in.

MAXIMUM BOLT BEARING STRESS IN Gr/Ep 45,080 PSI

**FIGURE 2-11 NASTRAN SUMMARY-1/2 LAMINATE 2.5 DIA HOLE REPAIR #1**

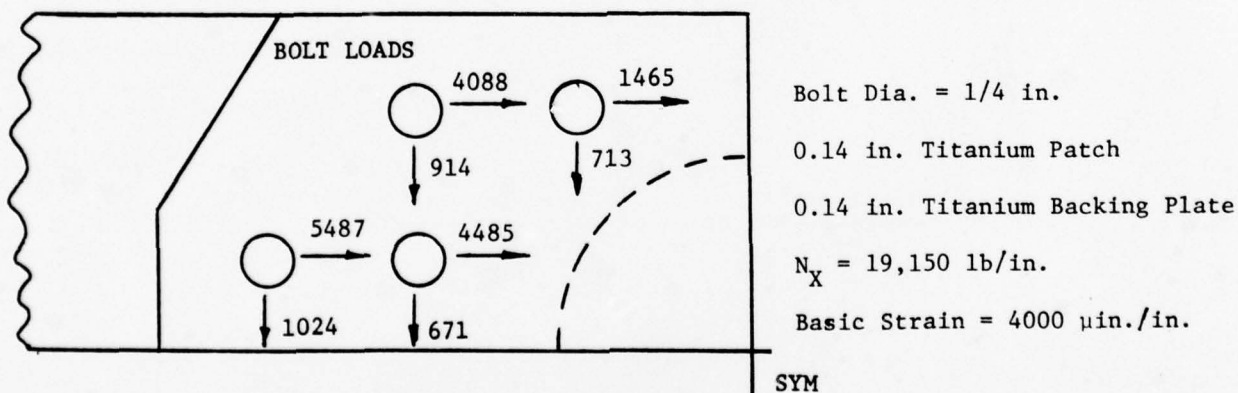
AT EDGE OF HOLE 9791  $\mu$ in./in.  
 AT ANY FASTENER 5334  $\mu$ in./in.  
 AT HIGHEST LOADED FASTENER - 5334  $\mu$  IN/IN

MAXIMUM BOLT BEARING STRESS IN Gr/Ep 44,653 PSI

**FIGURE 2-12 NASTRAN SUMMARY-1/2 LAMINATE 2.5 DIA HOLE REPAIR #2**

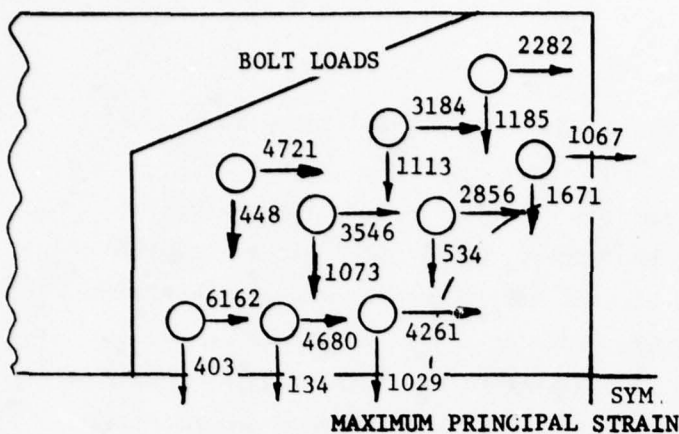
Bolt Dia. = 1/4 in.

0.14 in. Titanium Patch

MAX. BOLT BEARING STRESS IN Gr/Ep 51,565 psi

FIGURE 2-13 NASTRAN SUMMARY-1/2 LAMINATE 4.0 DIA HOLE REPAIR #1

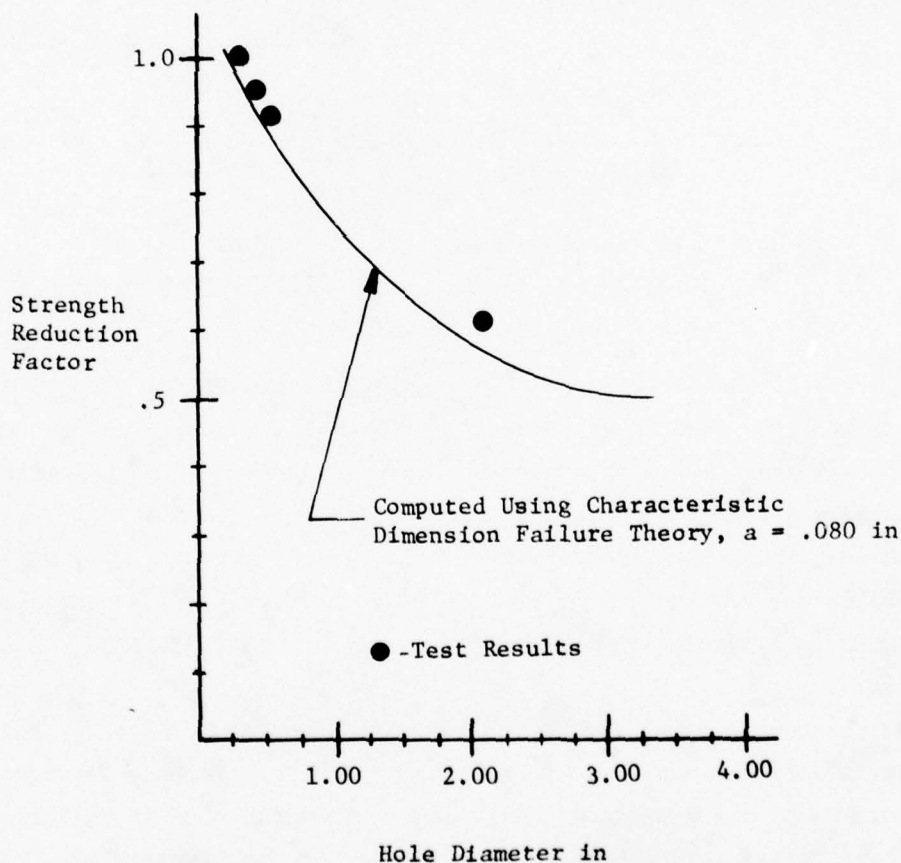
FIGURE 2-15 HOLE SIZE VS STRENGTH REDUCTION FACTOR FOR GR/EP LAMINATES

Figure 2-15 shows the expected strength reduction for AS/3501-6 graphite/epoxy. This curve shows good agreement with available test results from Ref. (1), and shows that for the hole sizes considered, strength reduction between 25% and 50% occur. The average unloaded hole tension failing strain for laminates containing 1/4" diameter holes in AS/3501-6 layups, typical of the AV-8B torque box skins, has been found to be 5200  $\mu\text{in./in.}$  This value can be used to determine the permissible strain at the hole edge for various diameters.

Using this baseline strength in conjunction with the reduction factors shown in Figure 2-15, the maximum strain levels at the edge of the hole were computed and are shown in Table 2.2.

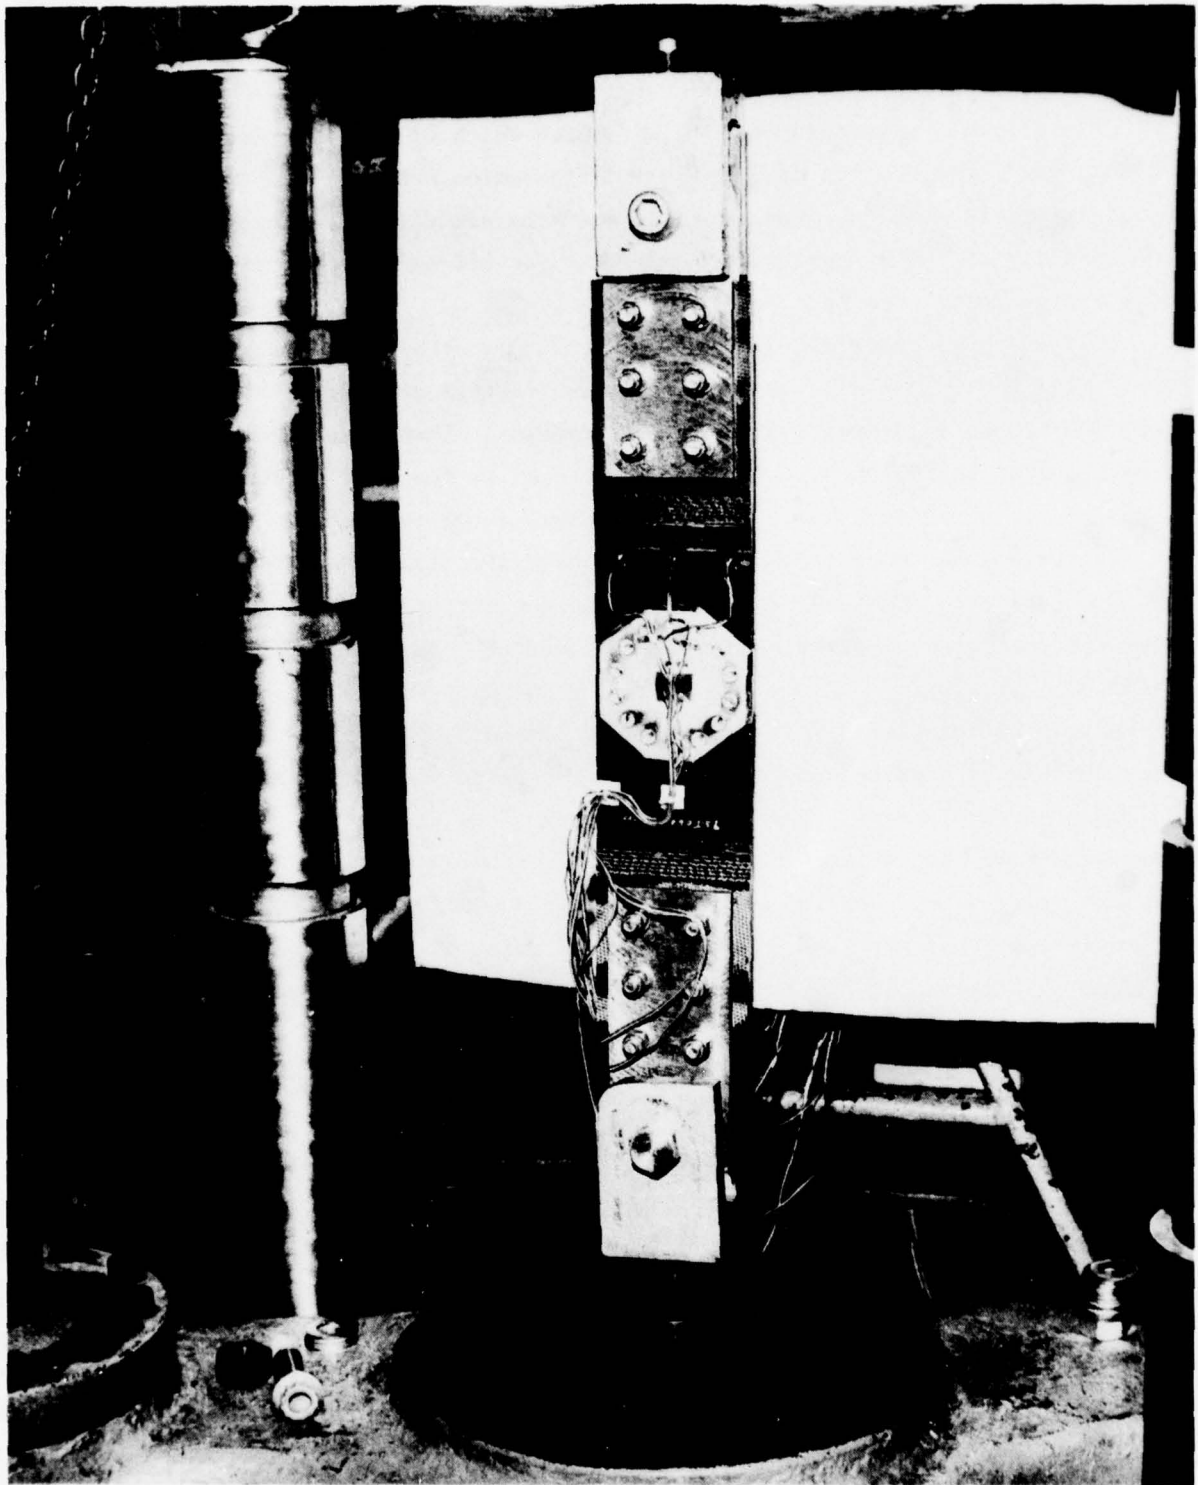
FIGURE 3-1 TYPICAL TENSION TEST SETUP

3.1.1 TENSION TESTS - All tension specimens for this program were tested on a 400,000 lb Baldwin-Lima Universal Test Machine. Load plates were bolted to each end of the repair specimens and attached to the test machine with a single-pin joint at each end. Figure 3-1 shows a typical tension test setup.

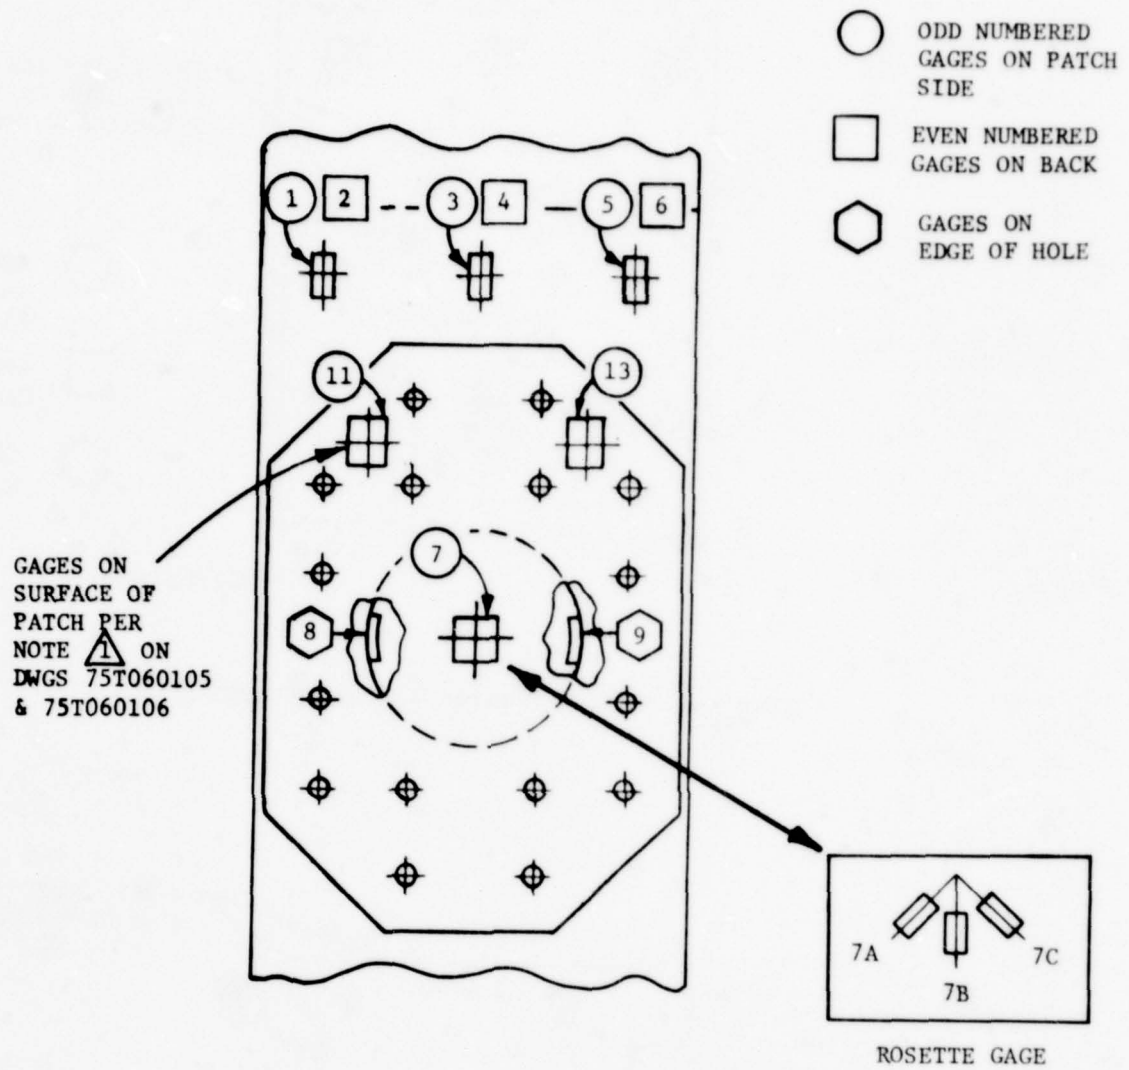
FIGURE 3-2 STRAIN GAGE INSTRUMENTATION  
INITIAL TESTS

Test specimens were strain gaged in accordance with the 75T060105 and 75T060106 assembly drawings, Figures A-5 and A-6 in Appendix A. Figure 3-2 shows the general arrangement and numbering of the strain gages on the initial specimens.

After initial tests, some changes were made on the instrumentation. The rosette gage was replaced on the center of the patch with an axial gage, and the other two strain gages were eliminated. See Figure 3-3. These extra gages had been intended to record any uneven load distribution. Initial tests however, showed that no significant uneven loading occurs. Some of the re-designed patches used in the follow-on tests did not allow room for the six axial gages used to measure gross laminate strain. On these specimens, two gages were mounted on the edges of the laminate as shown in Figure 3-4. All strain gage data presented later in this report will be identified as shown in Figures 3-2, 3-3, and 3-4.

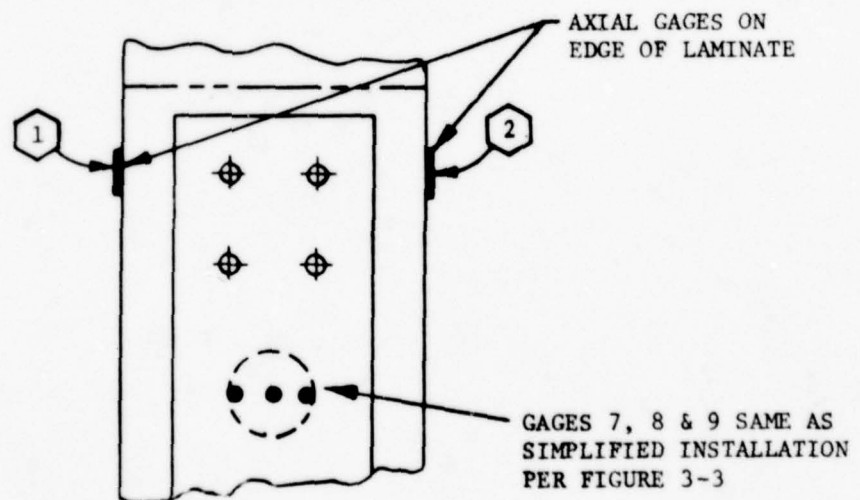
FIGURE 3-4 ALTERNATE SIMPLIFIED STRAIN GAGE INSTRUMENTATION

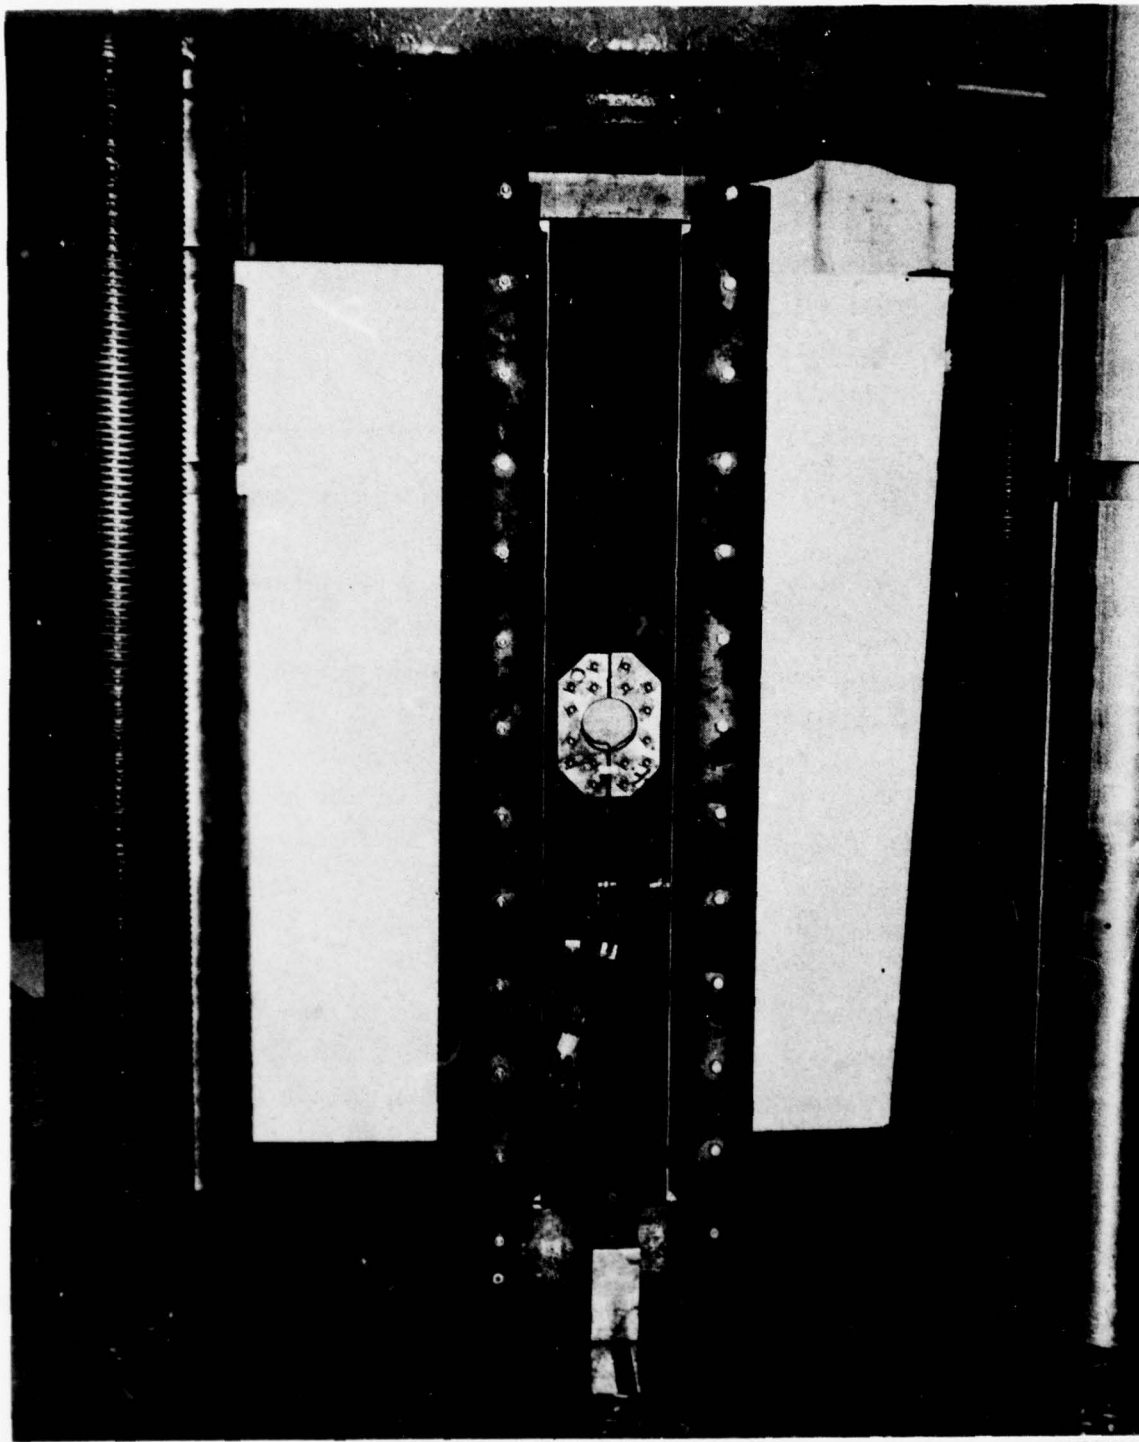
FIGURE 3-5 TYPICAL COMPRESSION TEST SETUP

The compression panels were loaded through blocks bonded to the ends of the specimens (see Figures A-5 and A-6 in Appendix A). The edges of the specimens were restrained by supports fabricated from steel pipe. Each pipe had a slot cut along its length in which the edge of the specimen edge was inserted. Bolts through the pipe provided clamping force to support the specimen edge securely. Drawing 75T060107 (Figure A-7, Appendix A) defines the pipe edge supports. Figure 3-5 is a photograph of a typical compression test setup.

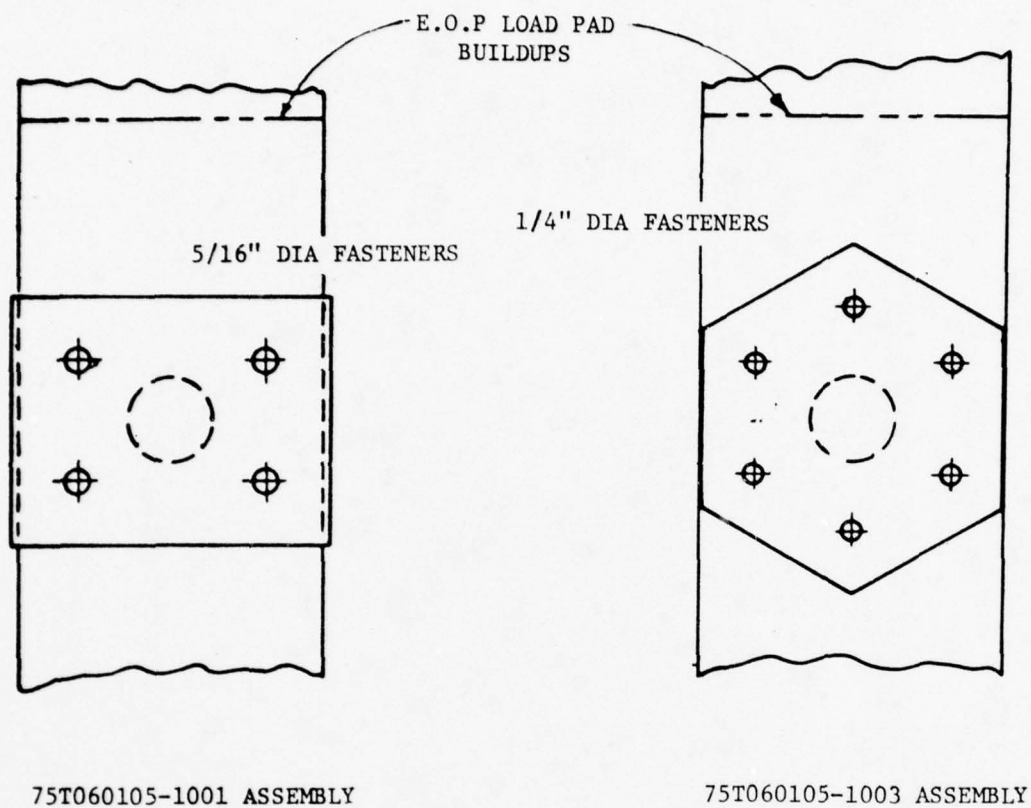
Part Name	Drawing Part Number	
	4-Bolt Configuration	6-Bolt Configuration
Repair Assy	75T060105-1001	75T060105-1003
Patch Details	75T060103-2011/-1013	75T060103-2009/-1011
Gr/Ep Specimen	75T060101-1001	75T060101-1001

FIGURE 3-6 3/16 LAMINATE 1.0 DIA DAMAGE HOLE INITIAL DESIGNS

The two initial repair designs tested for 3/16 in. laminates with 1.0 in. holes are shown in Figure 3-6. These specimens are fully defined in the

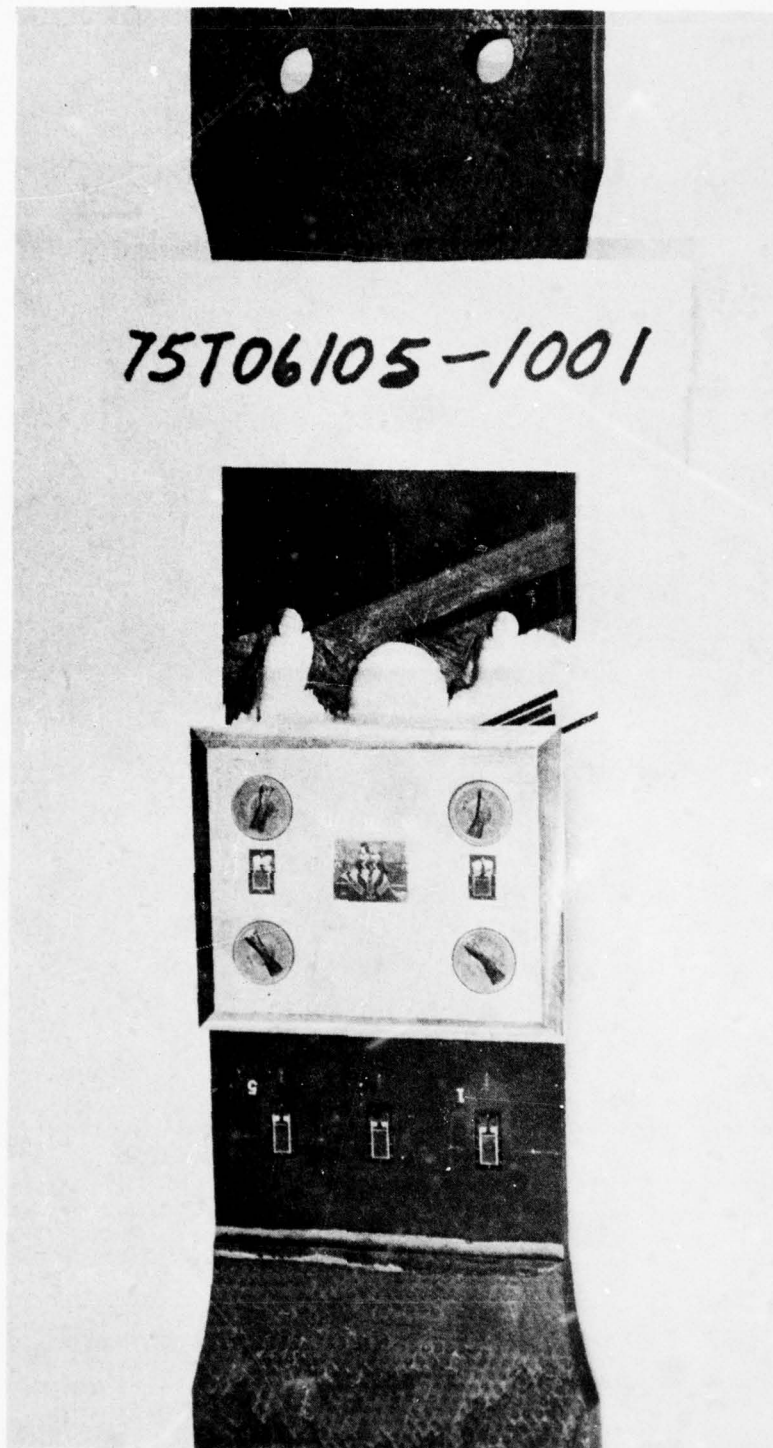
**FIGURE 3-7**  
**FAILED 75T060105-1001 SPECIMEN**  
**3/16 Laminate 1.0 Diameter Damage Hole**

The 75T060105-1001 (4 bolt) repair failed at 23,300 lb producing 3,846  $\mu\text{in./in.}$  average laminate strain. The specimen failed in the net section across the damage hole and the laminate failed around the patch fasteners as shown in Figure 3-7.

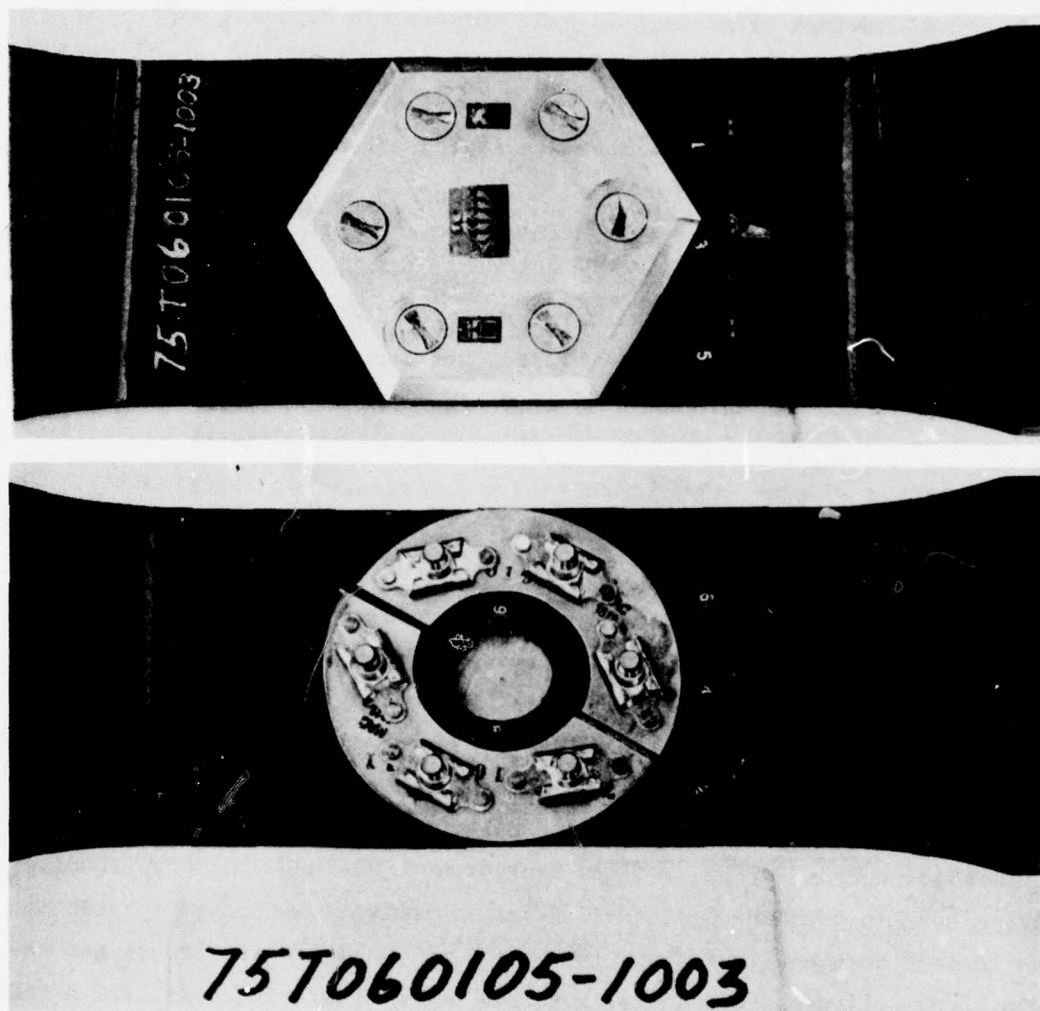
FIGURE 3-8  
FAILED 75T060105-1003 SPECIMEN  
3/16 Laminate 1.0 Diameter Damage Hole

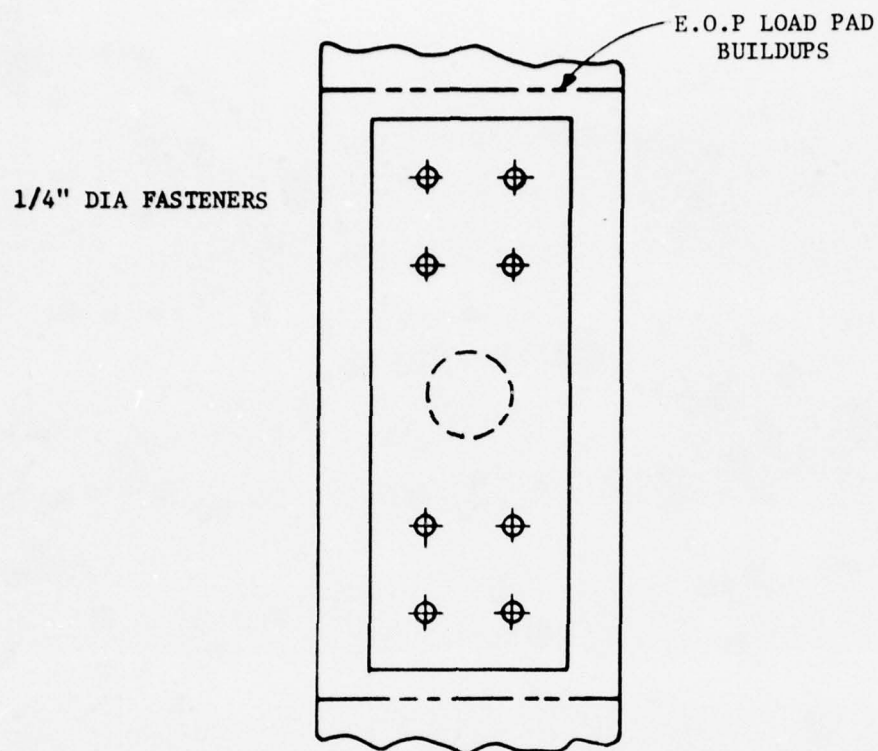
75T060105-1019 ASSEMBLY

Part Name	Drawing Part Numbers
Repair Assy	75T060105-1019
Patch Details	75T060104-2011/-1019
Gr/Ep Specimen	75T060101-1001

FIGURE 3-9 3/16 LAMINATE 1.0 DIA DAMAGE HOLE  
FOLLOW-ON TEST DESIGN

Figure 3-9 shows the revised configuration tested on the final two 3/16 laminates. The table included in that figure lists the parts which comprise the specimen assembly (Ref Appendix A, Figures A-1, A-4, and A-5).

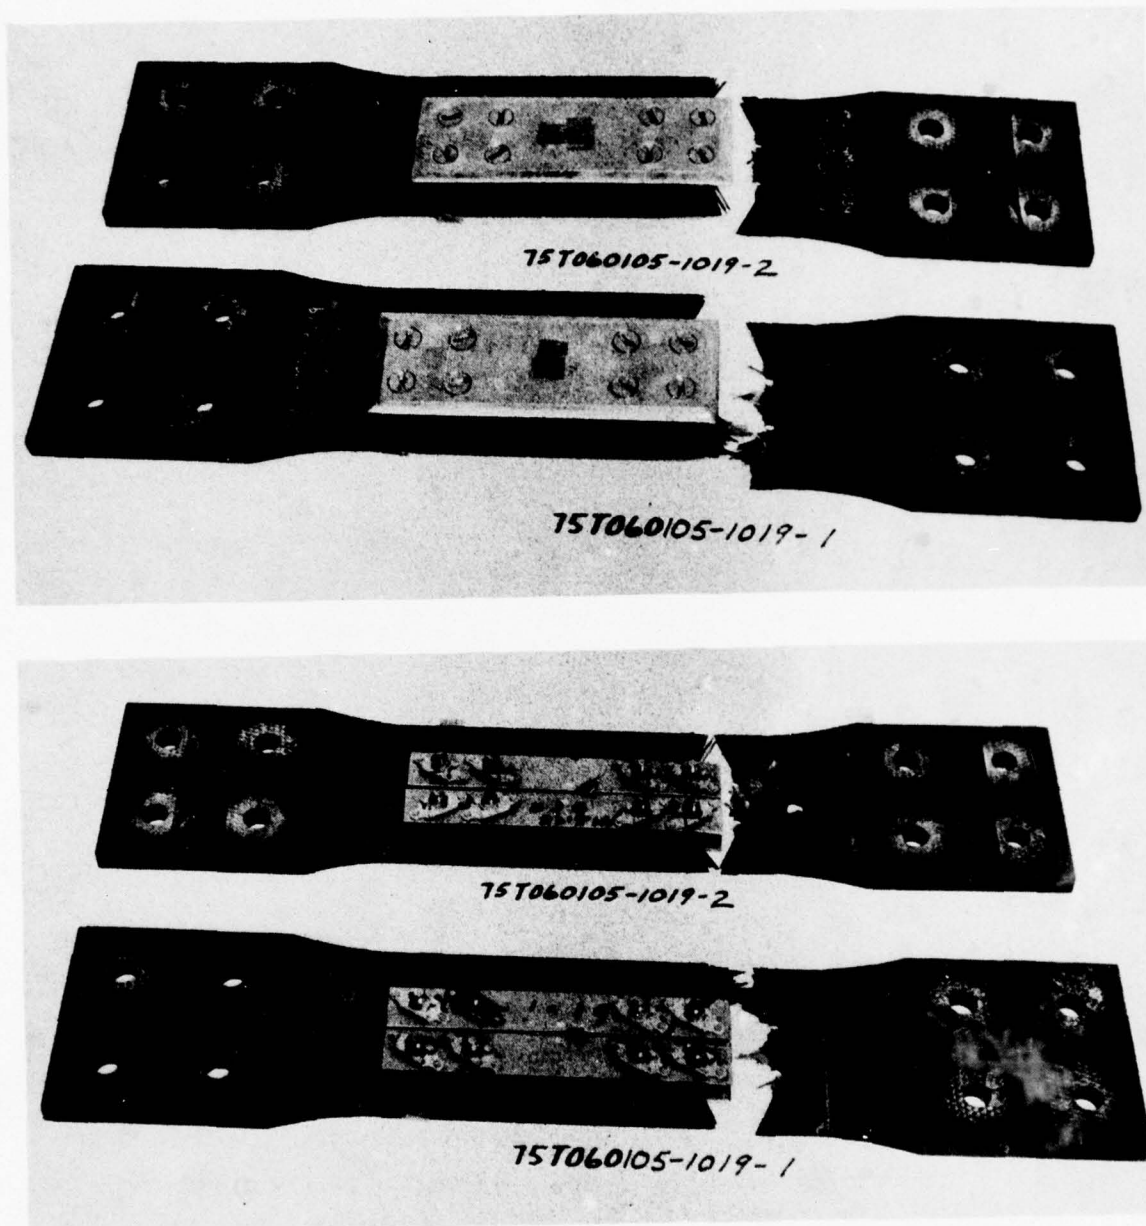
**FIGURE 3-10**  
**FAILED 75T060105-1019 SPECIMENS**  
 3/16 Laminate 1.0 Diameter Damage Hole

The new 8-bolt configuration was a significant improvement. Failures at 37,000 and 35,600 lb produced average laminate strains of 5,712 and 5,604  $\mu\text{in./in.}$ , respectively. Strains at the edge of the damage hole were 15,175 and 13,083  $\mu\text{in./in.}$  Patch strains were 875 and 980  $\mu\text{in./in.}$  Failure came along the outer bolt line at one end of each specimen. See Figure 3-10.

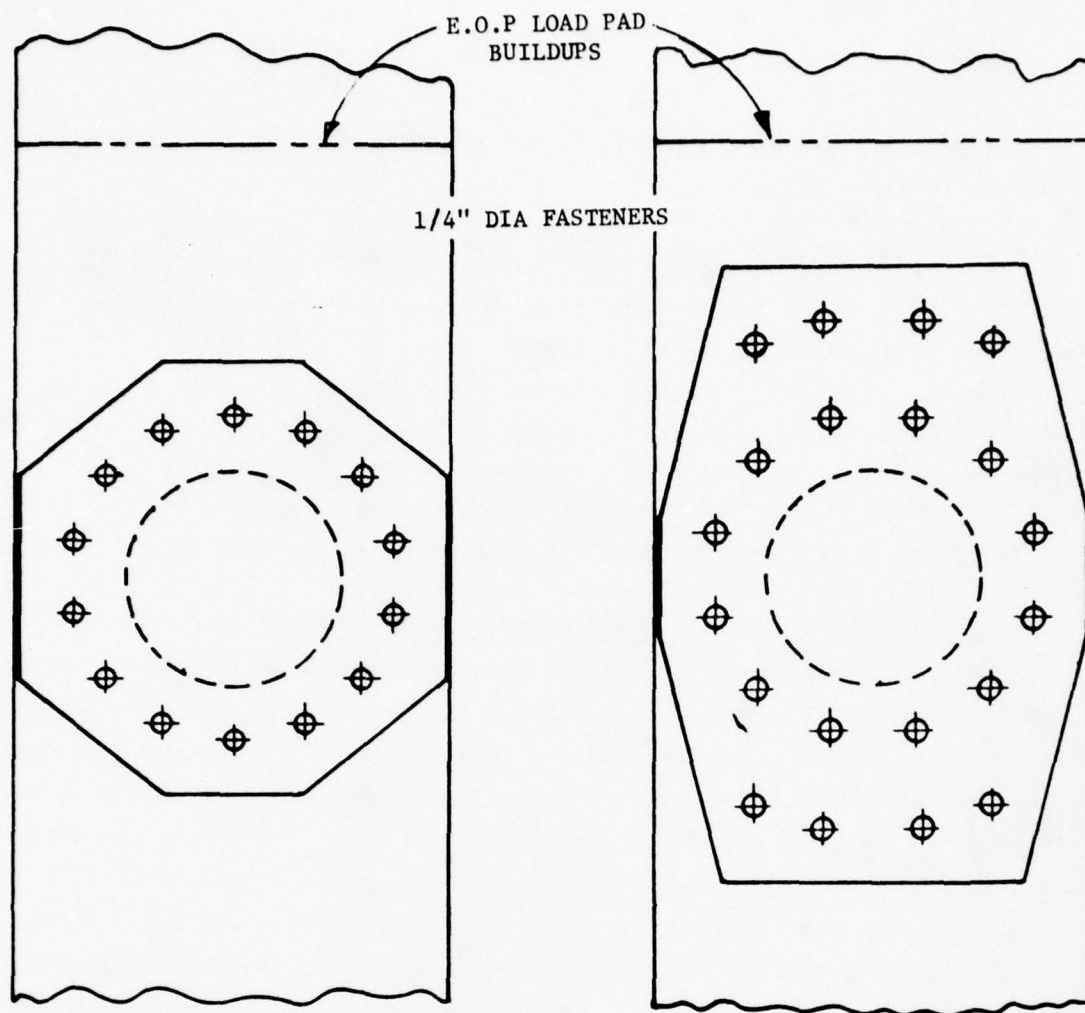
75T060105-1007 ASSEMBLY

75T060105-1005 ASSEMBLY

FIGURE 3-11 3/16 LAMINATE 2.5 DIA DAMAGE HOLE REPAIR DESIGNS

Both patch designs produced acceptable test results. The 75T060105-1007 has merit due to the fewer number of fasteners and simple fastener pattern. However the 75T060105-1005 was chosen for follow-on testing because it carried a higher load at failure. The two additional specimens failed at 42,100 and

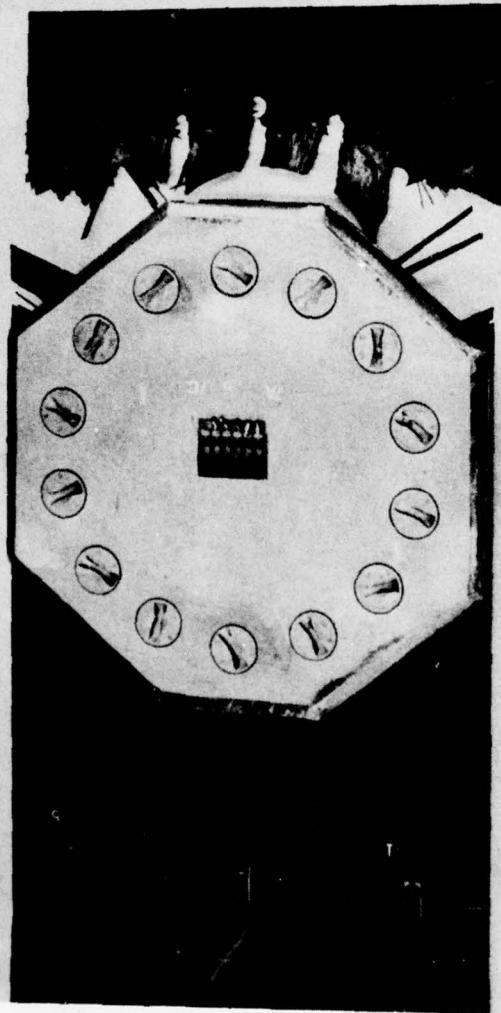
FIGURE 3-12  
FAILED 75T060105-1007 SPECIMEN  
3/16 Laminate 2.5 Diameter Damage Hole

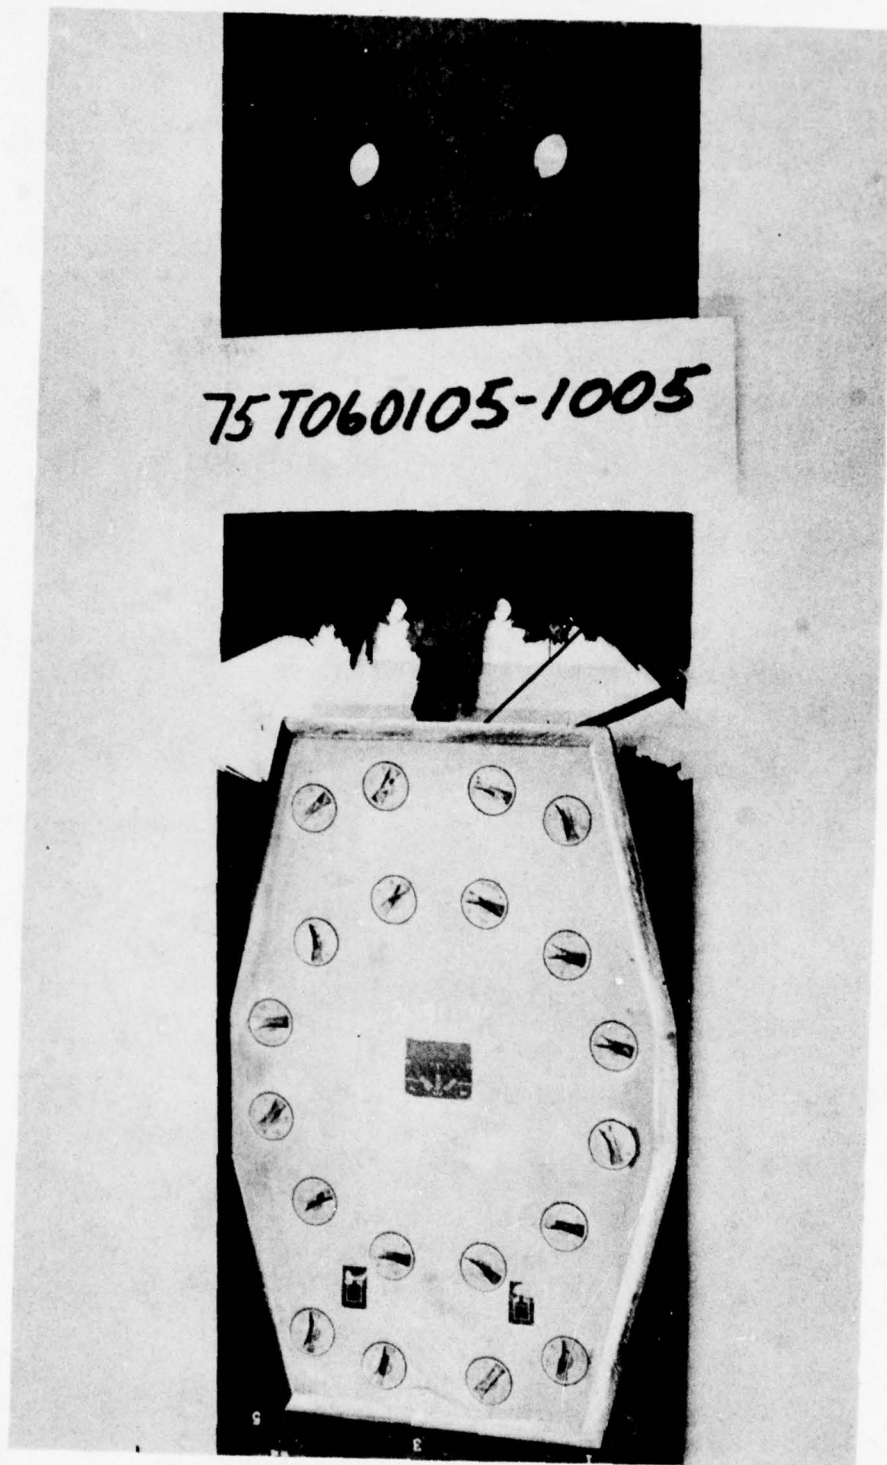
FIGURE 3-13  
FAILED 75T060105-1005 SPECIMEN  
3/16 Laminate 2.5 Diameter Damage Hole

The 75T060105-1005 (rectangular pattern) repair specimen failed at 46,000 lb, with 5,316  $\mu\text{in./in.}$  average laminate strain. Failure occurred along the outermost row of fasteners at one end of the specimen (see Figure 3-13). At failure, the patch strain was measured at 1,569  $\mu\text{in./in.}$  at the center. The strain at the edge of the laminate hole was in excess of 10,000  $\mu\text{in./in.}$  (Exact strain value was undetermined because the strain range was set at 10,000  $\mu\text{in./in.}$  in the data recording equipment). Complete strain gage data is presented in Appendix B, Figure B-5.

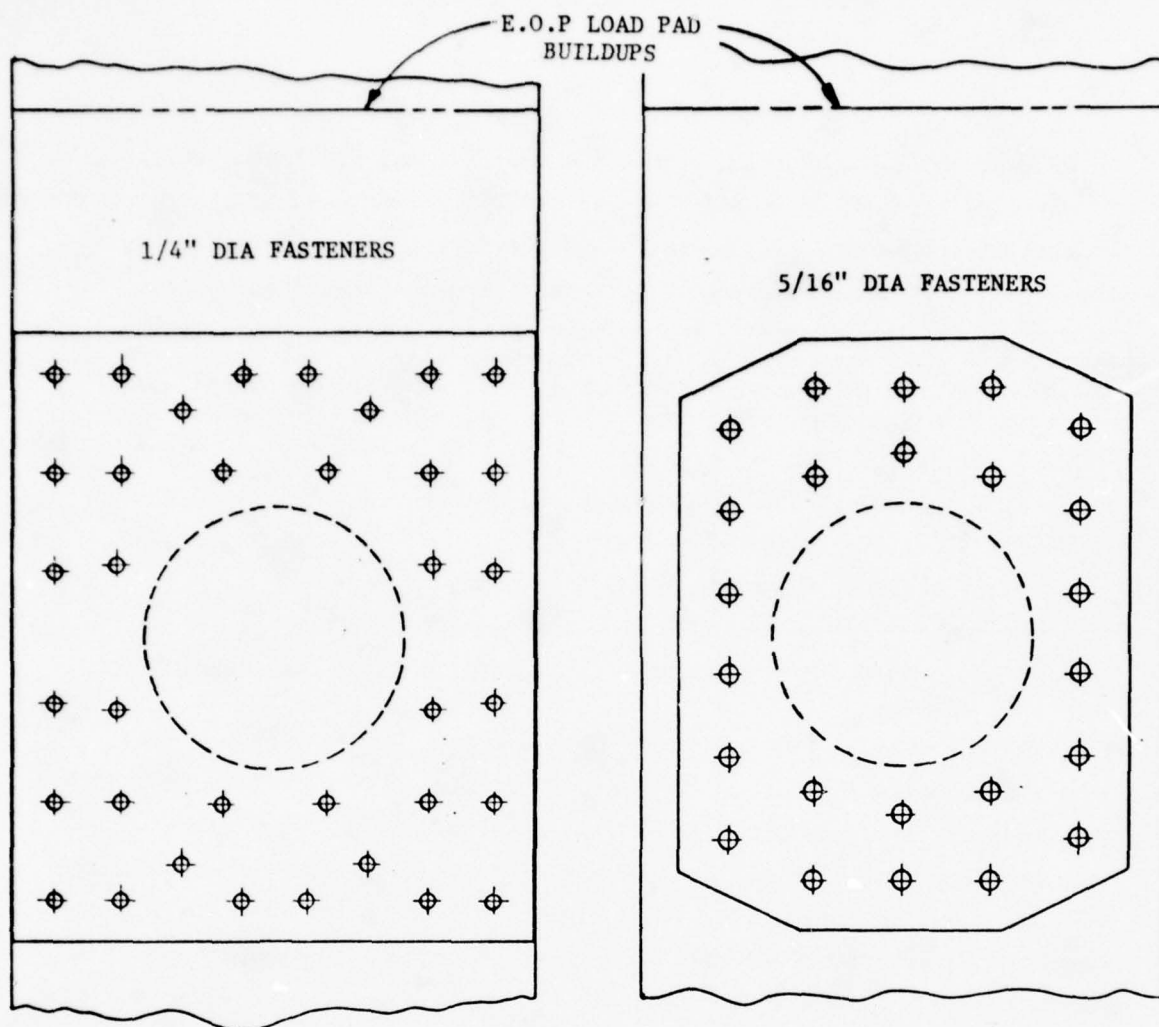
75T060105-1013 ASSEMBLY

75T060105-1011 ASSEMBLY

Drawing Part Number	
	36 Fastener Config (1/4 in. fasteners)	24 Fastener Config (5/16 in. fasteners)
Repair Assy	75T060105-1013	75T060105-1011
Patch Details	75T060103-2005/1005	75T060105-2007/-1007/-1009
Gr/Ep Specimen	75T060101-1005	75T060101-1005

FIGURE 3-14 3/16 LAMINATE 4.0 DIA DAMAGE HOLE INITIAL DESIGNS

The two titanium patches designed to repair a 4.0 inch hole in a 3/16 inch laminate are shown in Figure 3-14, along with a table of parts which make up these assemblies. The Engineering drawings (Figures A-1, A-3, and A-5) are found in Appendix A. In designing a patch to repair such a large damage hole, an effort was made to keep the total patch area as compact as possible. This allows application of the repair patch over a larger portion of the wing skin without interfering with adjacent substructure. The two designs presented feature two different sizes of fasteners in similar closely spaced bolt patterns.

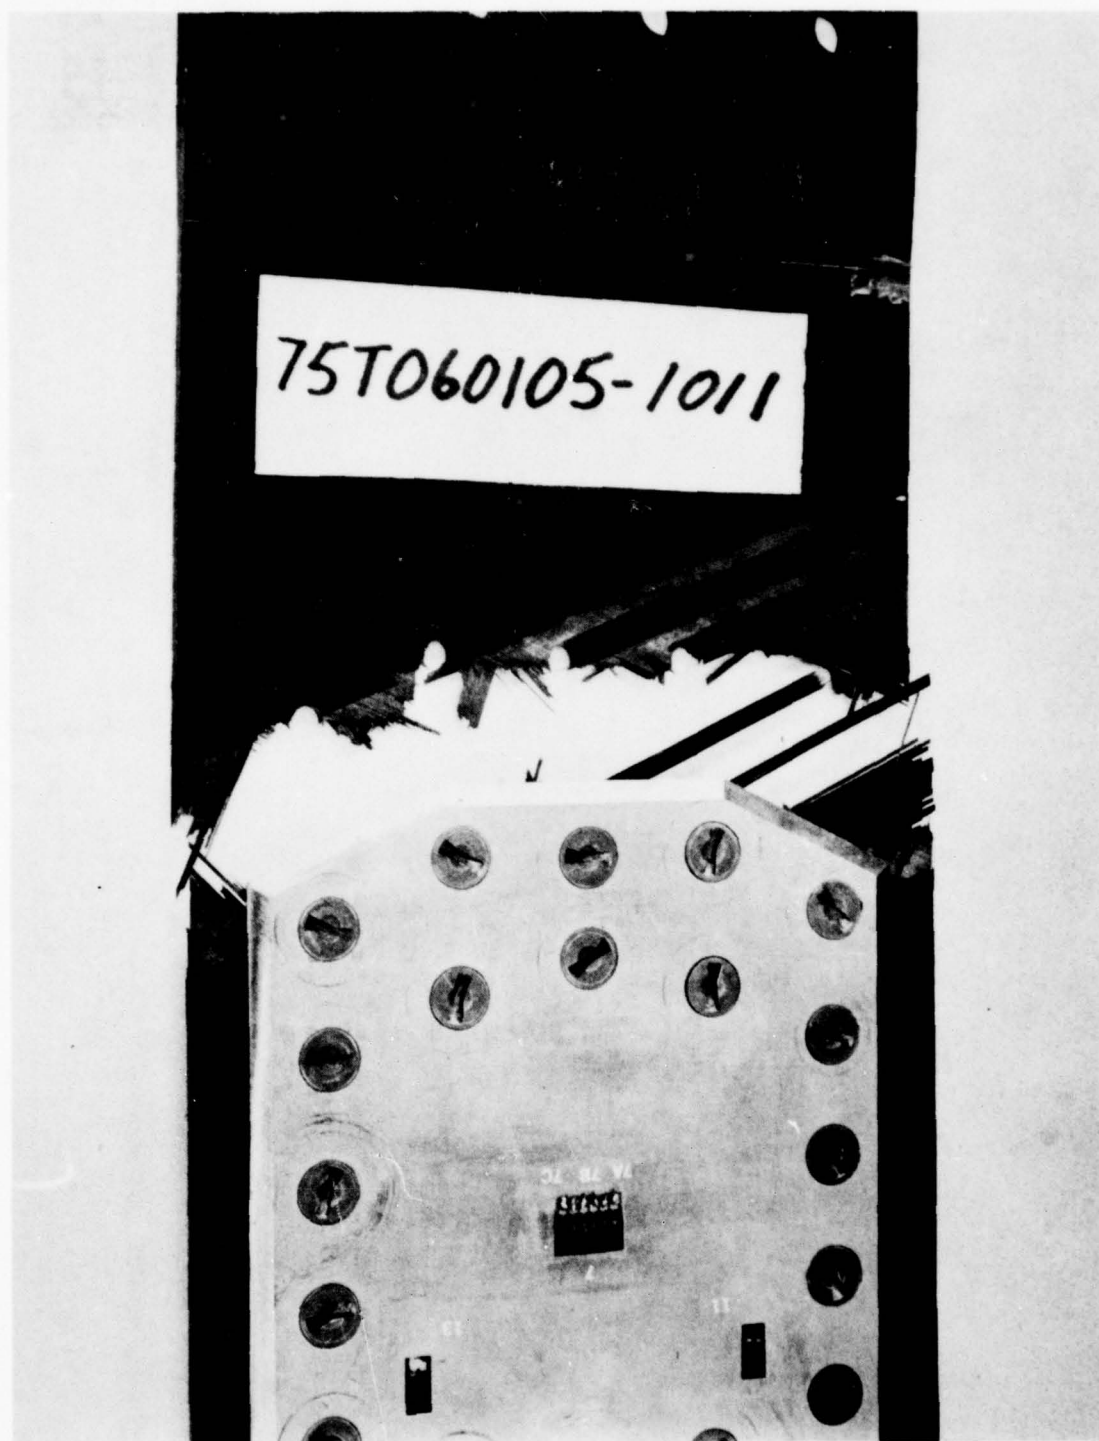
FIGURE 3-15  
FAILED 75T060105-1011 SPECIMEN  
3/16 Laminate 4.0 Diameter Damage Hole

The initial test on the 5/16 inch fastener configuration brought failure at 62,500 lb and a gross laminate strain of 4,540  $\mu\text{in./in.}$  The 1/4 in. fastener concept failed at 65,500 lb and 4,758  $\mu\text{in./in.}$  strain. Both failures were along an outermost row of fasteners. Figures 3-15 and 3-16 show the failures. Both concepts thus exceeded 4,000  $\mu\text{in./in.}$ , with the 1/4 in. dia. fastener concept slightly better.
